Rose Hill Street Temporary Traffic Calming

ROOSEVELT STREET TO VISTA AVENUE

Final Report | September 2022

Alternatives Technical Memorandum

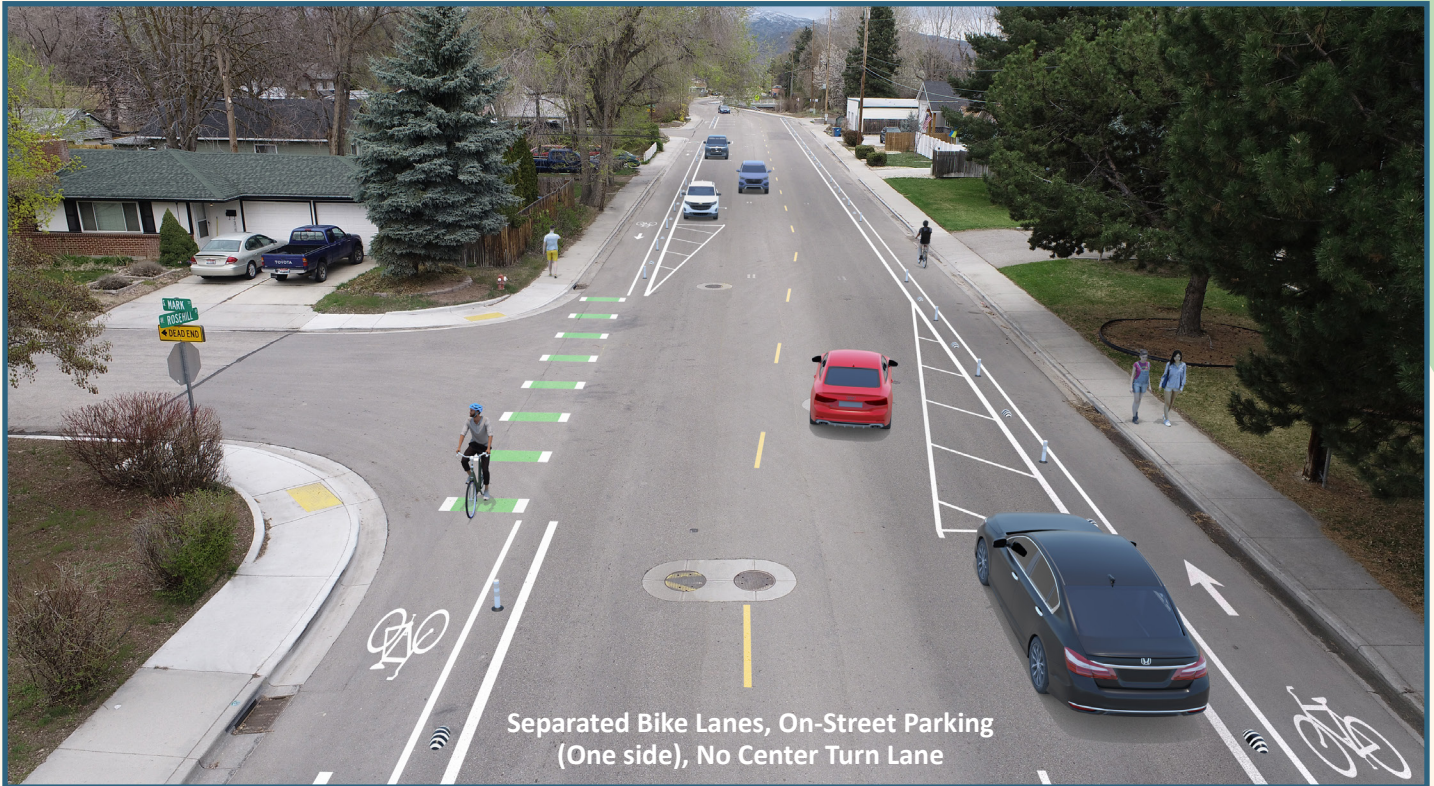
Rose Hill Street Temporary Traffic Calming, Roosevelt St / Vista Ave Recommended Concept

Recommended Concept SEPARATED BIKE LANES, ONE SIDE PARKING, NO CENTER TURN LANE

- Addition of on-street bike lanes, separated by a painted buffer with candles, armadillos, or planters
- Removal of the continuous center left-turn lane
- Retains parking on one side of the street
 - Alternates sides of the road to provide shifts in the travel lanes
- Potential to add left-turn lane and remove parking lane in certain areas

**This concept was the #1 choice of Rose Hill corridor residents
and the #2 choice of the general public.**

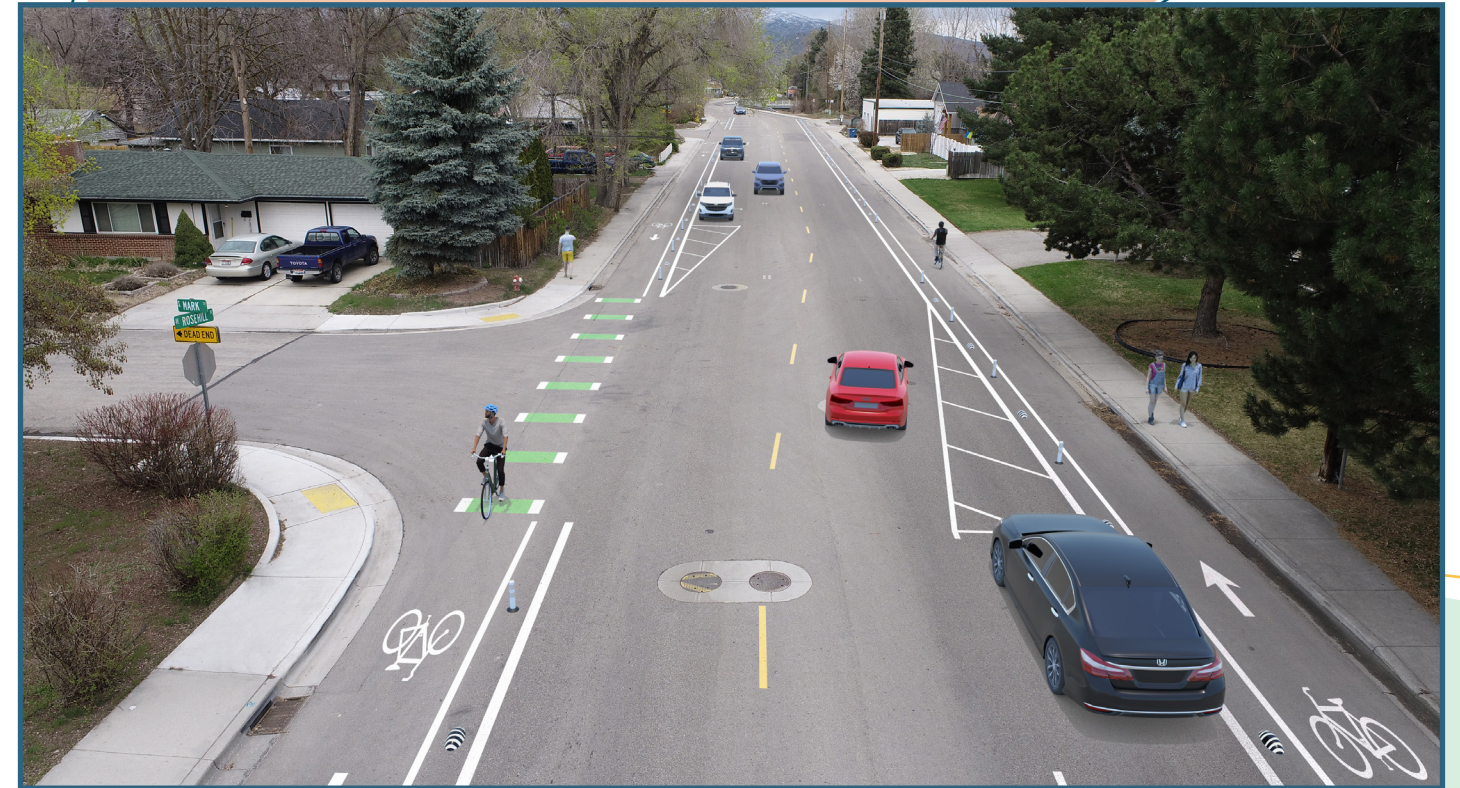
BENEFITS	CONSIDERATIONS
Results in bicycle level of traffic stress 1 or 2, depending on final separation materials	Removes center turn lane, which will add delay to through traffic
Maintains some parking/delivery access	Increases potential for rear-end crashes with no turn lane
Narrows the road and provides horizontal deflection	
Significant speed reduction anticipated (3-6 mph), depending on level of treatments installed

- Add on-street bike lanes on both sides of the street, separated from the travel lanes by physical separators.
- Retain on-street parking on one side of the street, except between Latah Street and Owyhee Street, where the road is narrower.
- Alternate the on-street parking from one side to the other to help slow traffic.
- Remove the center turn lane.
- Not impact the existing pavement or sidewalks along the corridor.

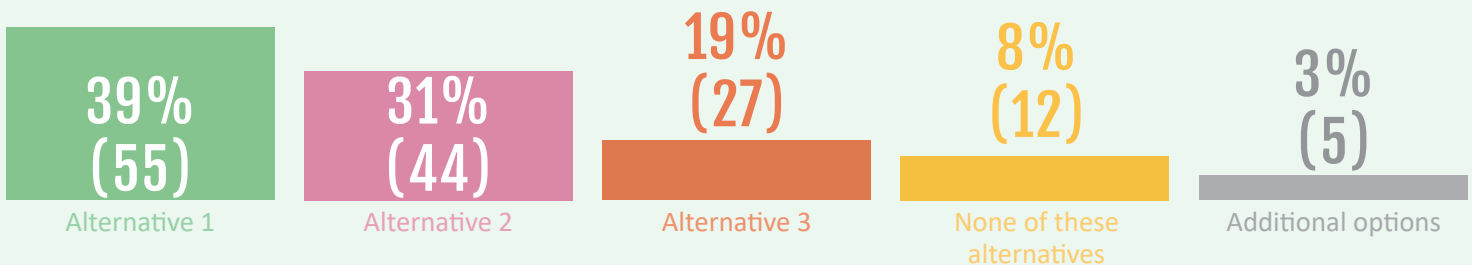
Which Alternative would people prefer to see tried out? (all responses)

WOULD YOU SUPPORT TRYING THESE CONCEPTS?

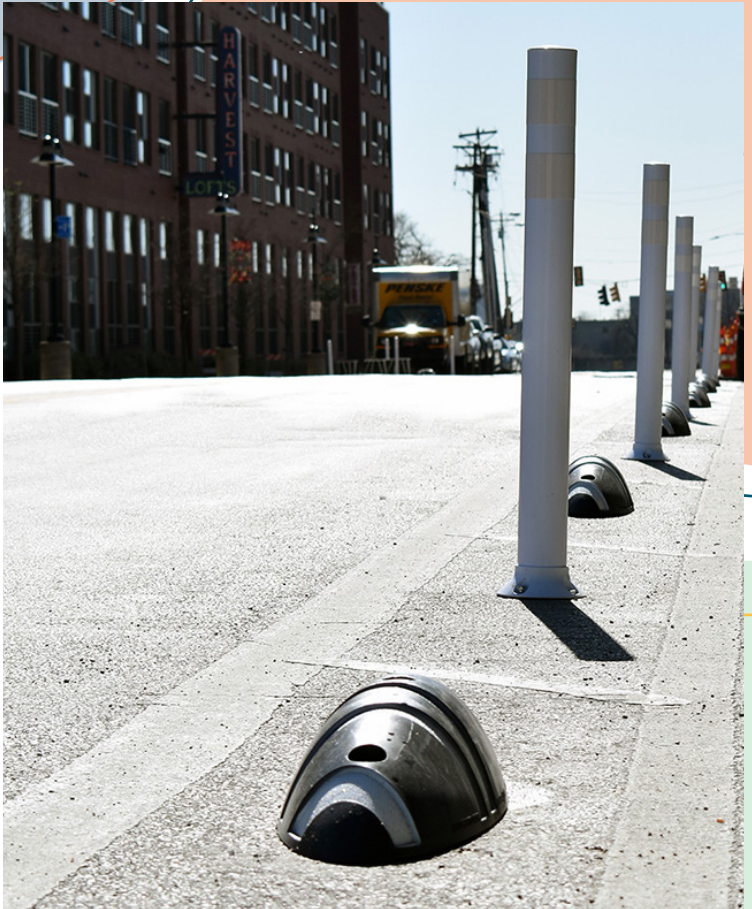
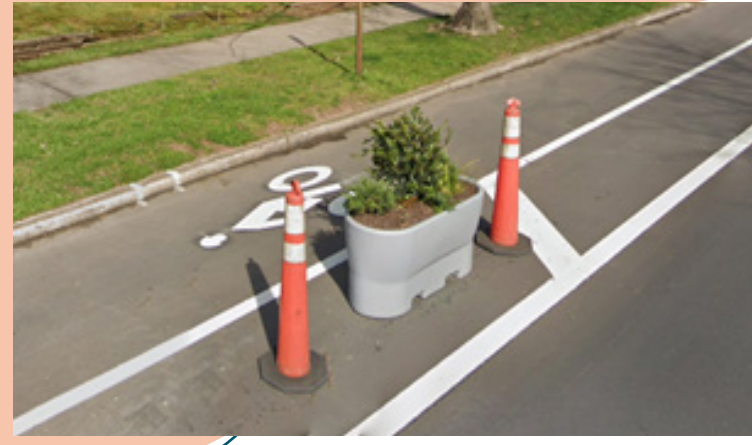
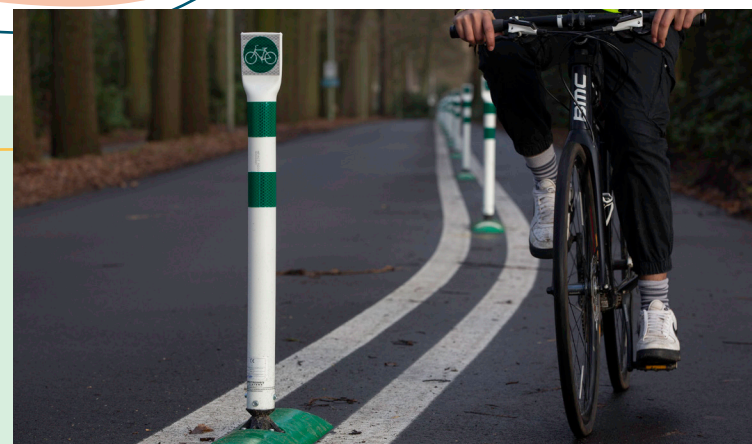
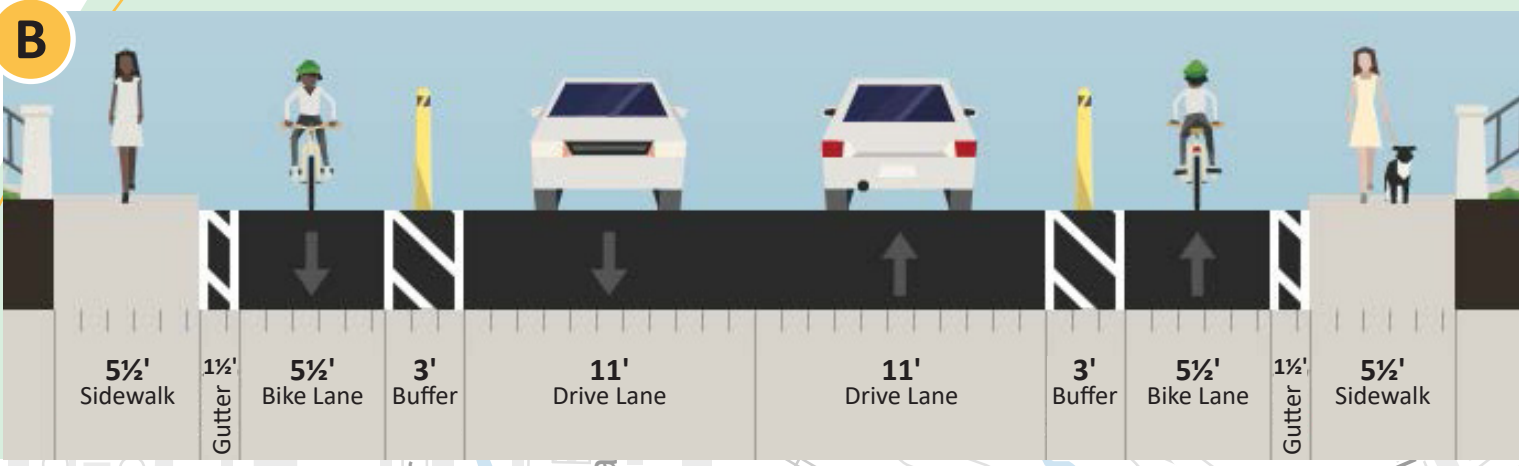
BENEFITS	CONSIDERATIONS
Results in bicycle level of traffic stress 1 or 2, depending on final separation materials	Potentially removes all parking, limiting opportunities for delivery and maintenance vehicle parking to side streets and driveways
Maintains center turn lane	Maintains long, straight sections of road, unless the center turn lane is removed and chicanes are added for sections
10' drive and turn lanes may help slow motor vehicle speeds	
Moderate speed reduction anticipated (1-6 mph), depending on level of treatments installed

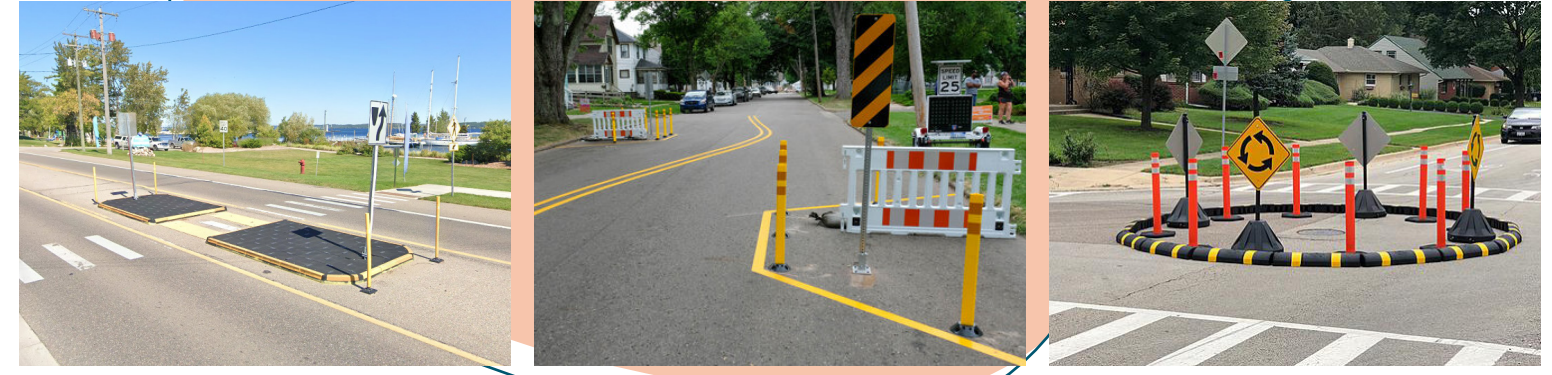
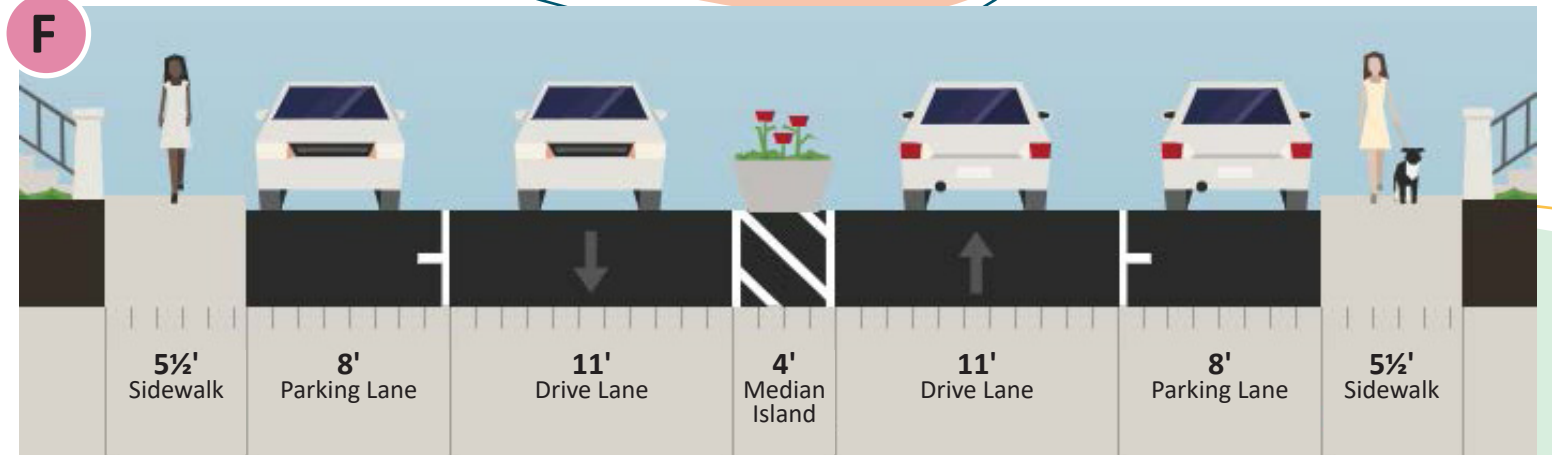
Alternative 3 CHICANES/MEDIAN ISLANDS

- Removal of the continuous center left-turn lane and/or parking lane
- Introduces horizontal deflection with the addition of median islands and chicanes
- Median Islands and chicanes created with semi-permanent materials
- Bike lanes are not added to the street

BENEFITS	CONSIDERATIONS
Potentially maintains the most parking of all alternatives	Does not add bikes lanes to Rose Hill Street
Introduces horizontal deflection with the addition of median islands and chicanes	If removing center turn lane, there will be added delay to through traffic and increased potential for rear-end crashes
Significant speed reduction anticipated (3-6 mph)

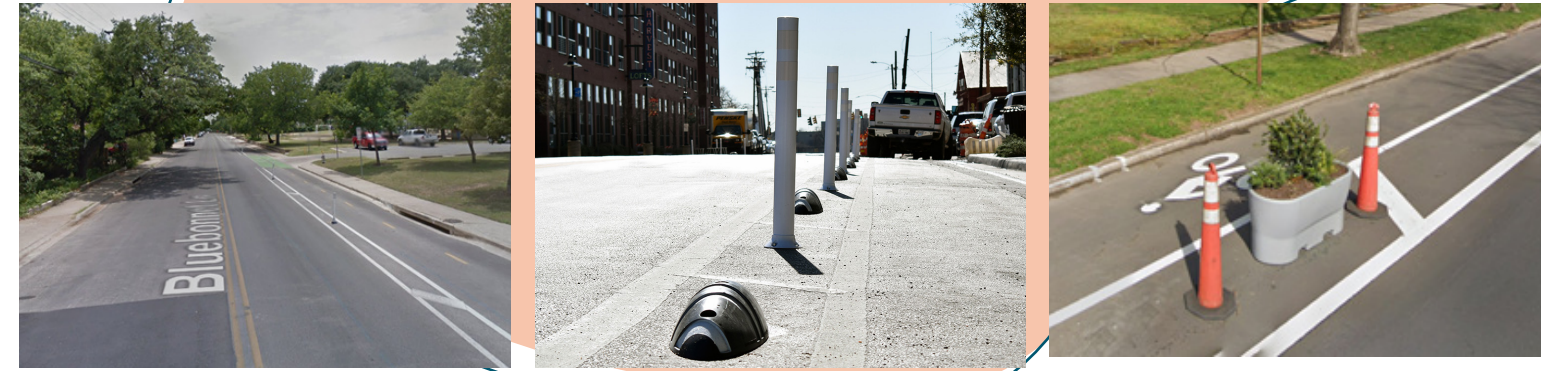
Alternative 4 CYCLE TRACK

- Addition of on-street two-way cycle track on the north side of the road, separated by a painted buffer with candles, armadillos, or planters
- Options for retaining the continuous center left-turn lane or one parking lane on either side of the street
- Would require modifying the current mini-roundabout design at Owyhee Street to accommodate the cycle track

BENEFITS	CONSIDERATIONS
Results in bicycle level of traffic stress 1 or 2 depending on final separation materials	Mini-Roundabout at Owyhee (permanent improvement) would need to be redesigned accommodate the cycle track (temporary improvement)
Maintains either one parking lane or the center turn lane	Requires transition from two-way cycle track to no bike facilities west of Roosevelt Street
Moderate speed reduction anticipated (1-6 mph)	Removes either the center turn lane or both parking lanes
	Maintains long, straight sections of road, unless chicanes are added for sections
	Buffer will have several gaps for residential driveways, which could make contraflow biking uncomfortable given the traffic volumes

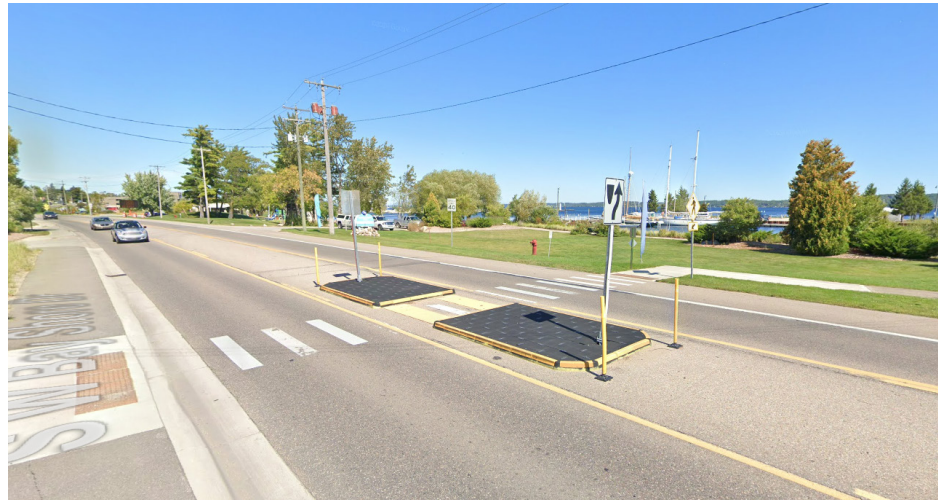
Add Pedestrian Crossing at Cleveland Street

- Includes a median refuge island with temporary materials
- Would remove the left-turn lane at the intersection

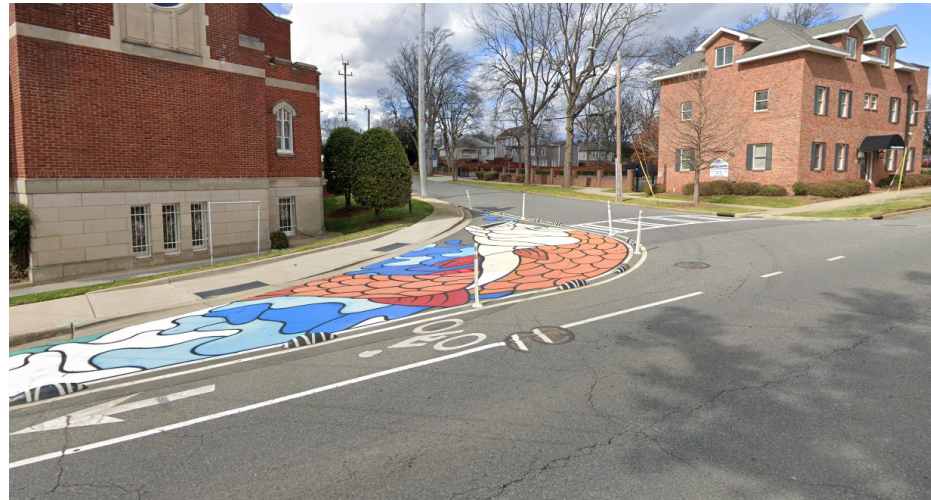
Add Corner Treatments at Vista Avenue

- Candles and/or armadillos and paint create buffer zone to tighten turning radius and shorten crossing distance at northwest corner and southwest corners
- Move stop bar back

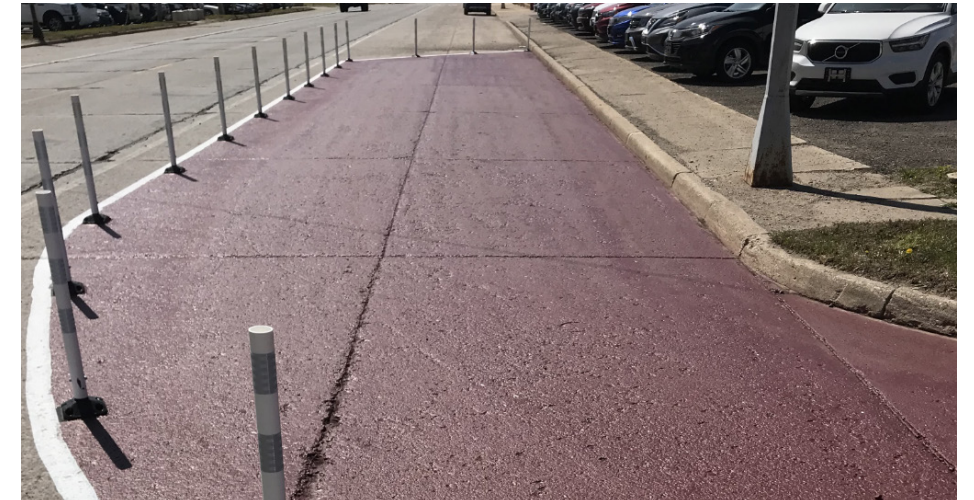
Increase Sight Distance at Peasley Street

- Narrow roadway with temporary buffer and remove parking east of Peasley Street
- Leave dedicated parking spaces for home with no driveway

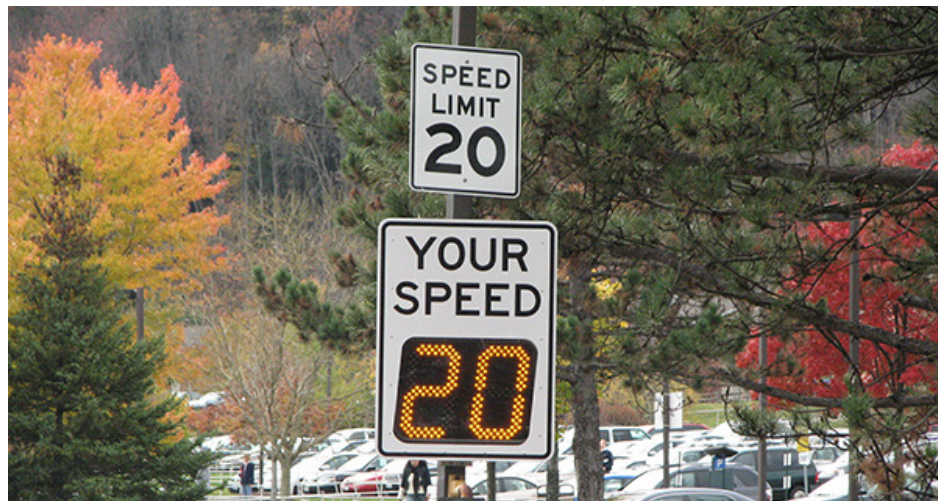
Add Speed Limit Feedback Signs

- Provides real time speed feedback to vehicles
- Drivers who are unintentionally speeding may slow down

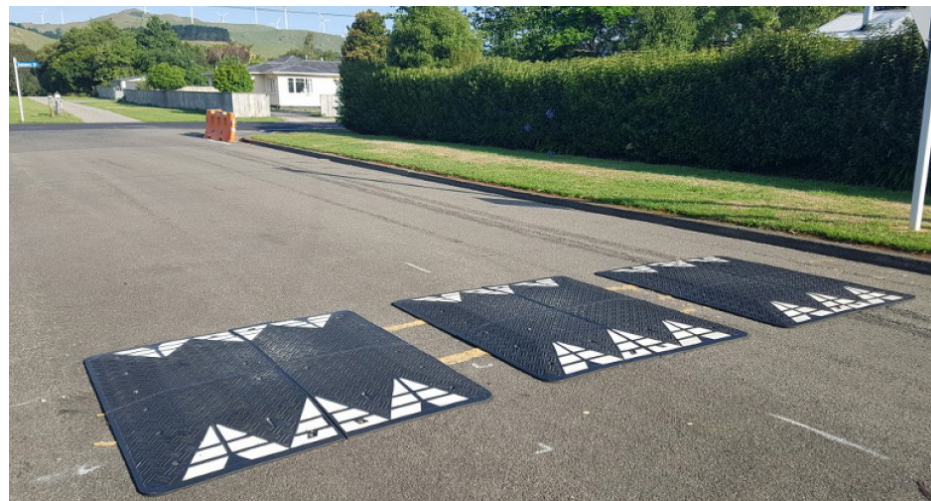
Add Speed Humps/Cushions

- Provides vertical deflection to slow vehicles
- ACHD policy does not allow for speed humps/cushions on arterials, so it would require a design exemption

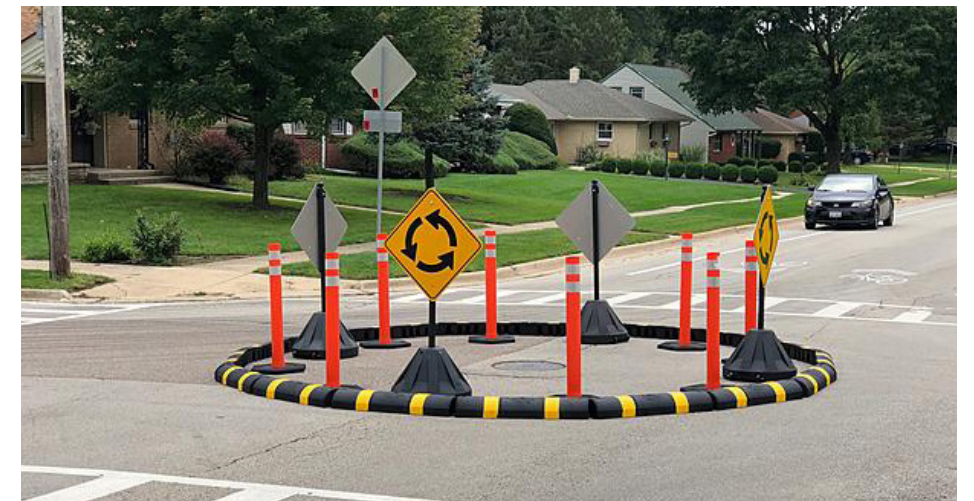
Add Traffic Circles

- Constructed with semi-permanent materials
- Potential locations include at Hanan Drive and Ruby Street

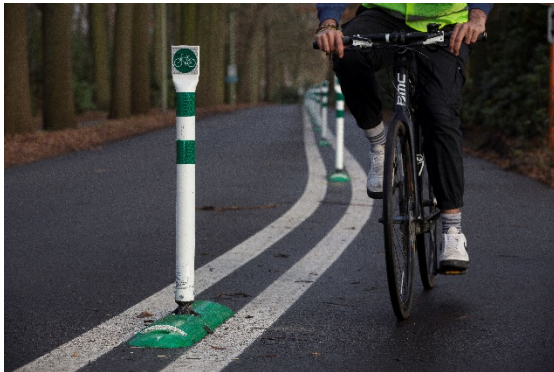
Figure 10 Example of Candles

Also known as tubular markers, they are installed by bolting directly into the pavement. They are designed to be flexible when hit but are prone to damage when hit repeatedly by vehicles. Replacement is necessary if they become broken. Candles are generally around 3' tall and are easy for drivers, cyclists, and plows to see, even with snow cover. Removal at the end of this project involves removing the bolts from the pavement.

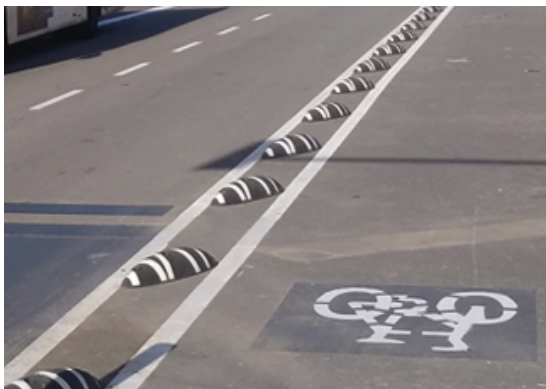
Figure 11 Example of Armadillos

Also known as zebra markers, they are installed by bolting directly into the pavement. They are designed to be rigid and are less prone to damage when hit by vehicles compared to some of the other materials presented here. The need for replacement is unlikely. Armadillos are generally around 6" tall, so they are not as visible as taller materials (e.g., candles). Reflective striping can help with nighttime visibility. The alternatives all recommend pairing armadillos with candles since the armadillos can provide a level of rigidity against motor vehicle strikes that candles cannot, while candles provide a level of visibility, especially on snow covered roads, that the armadillos do not. Removal at the end of this project involves removing the bolts from the pavement. One example of these products, called the Zebra Zero Cycle Lane Separator, can be found here: [ZICLA | Zebra Family®](#).

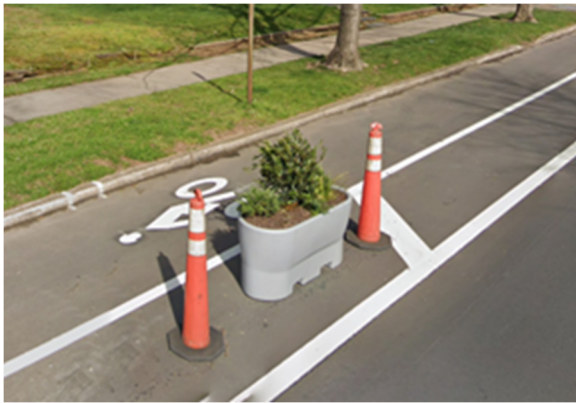
Figure 12 Example of Planters

These can be installed in painted buffer spaces to provide a physical vertical separator between a bike lane and a motor vehicle travel or on-street parking lane. Permanent installations may use concrete planters, while a temporary installation may use plastic or wooden boxes filled with soil and one or more plants. A key consideration with planter boxes is their maintenance. Planting and maintenance would likely need to be completed on a regular basis. For instance, if struck by a vehicle, the planter would need to be returned to the correct location or replaced. Regular watering or other plant-related maintenance may also be needed. Other jurisdictions have implemented agreements with neighborhood associations or other community organizations to be responsible for all planting and maintenance. They have also utilized high schools and trade schools for planter box construction. Alternatively, plastic and wood planter boxes can be purchased. Removal at the end of this project involves picking up the planters with potential for repurposing elsewhere or donation to a community organization.

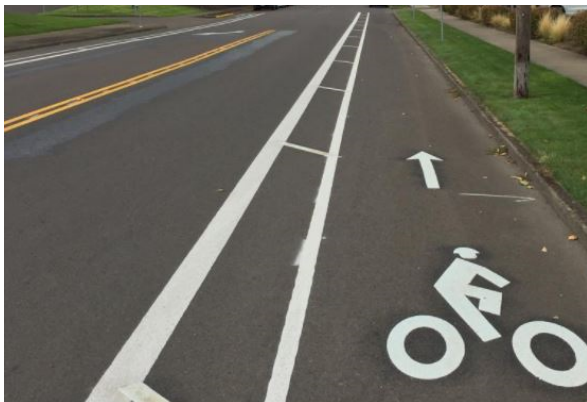
Figure 13 Example of Striping

Striping for a temporary installation would likely be completed using paint only, and not thermoplastic. It is an efficient way to demarcate space and separate uses or define travel paths, but it does not provide a vertical element or protection, which limits its effectiveness for traffic calming or providing a comfortable biking experience. Therefore, vertical elements are typically recommended in conjunction with striping when used for traffic calming or separating uses. Removal at the end of the project would involve completing pavement marking obliteration if changing the cross section is desired.

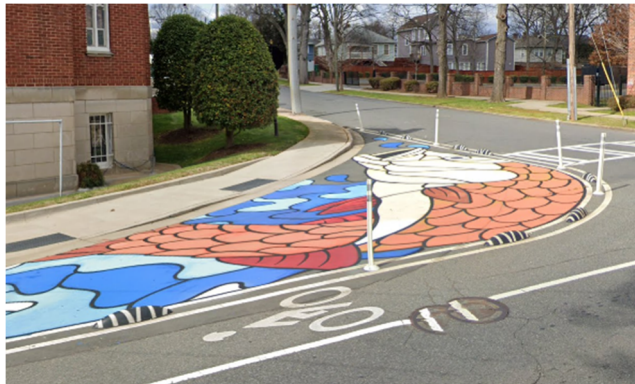
Figure 14 Example of Painted Areas

Painted areas

Large buffer areas with paint can be used to help demarcate a pavement space and restrict vehicle travel. They can be installed by painting an area one single color (e.g., like a bike box) or local artists or neighborhood groups have been used in other jurisdictions to create a more unique buffer space. Though these areas would not be driven on by vehicle traffic, they still would likely fade with time and require upkeep. Removal at the end of this project involves large scale pavement marking obliteration. A seal coat or roadway mill and overlay could be more efficient for completing this removal.

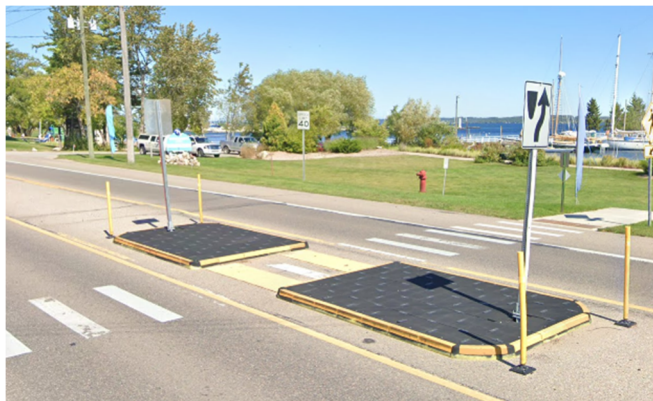
Figure 15 Example of Rubber Medians/Curb

These temporary vertical installations are used to create median islands, traffic circles, and define turning radii, and are installed by bolting directly into the pavement. They are designed to be rigid and hold up better to being hit by vehicles compared to some of the other materials presented here. The need for replacement is unlikely. Curbing is generally around 6" tall and painted yellow, however, they are not as visible as taller materials (e.g., candles). The alternatives recommend pairing rubber medians/curbs with candles since they can provide a level of rigidity against motor vehicle strikes that candles cannot, while candles provide a level of visibility, especially on snow covered roads, that the rubber medians/curbs do not. Removal at the end of this project involves removing the bolts from the pavement. One example of these products can be found here: [TreeTopProducts](https://www.treetopproducts.com/).

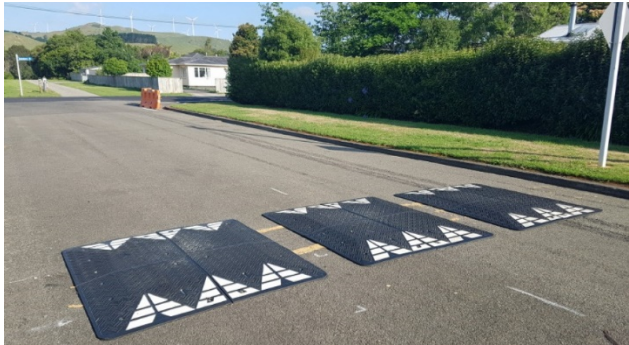
Figure 16 Example of Speed Humps/Cushions

Vertical deflection is not currently allowed on arterial roads according to ACHD policy. In order to install speed humps or cushions on Rose Hill Street, a design exception would be required. These products are usually rubber and are installed by bolting directly into the pavement. They are designed to be driven over and are unlikely to see any major damage unless hit by sharp edges, like snowplows. Removal at the end of this project involves removing the bolts from the pavement.

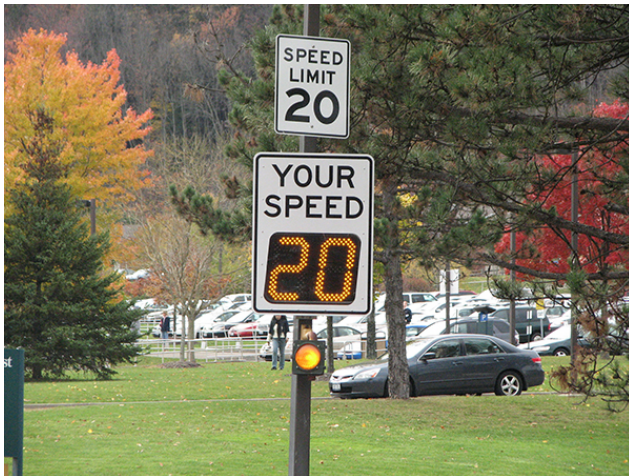
Figure 17 Example of Speed Feedback Signs

These are currently being installed across Ada County by ACHD. Implementation would be similar to other areas they are installed in. One key consideration for them is the need to provide a power source, either hardwire or solar. They can be added directly to existing speed limit signs or added in new locations.
